Flood Control Project Maintenance
Levee Inspections

Fall 2013 Levee Maintenance Deficiency Summary Report

Sacramento River Basin

| RD0999 Reclamation District No. 0999 Netherlands | Overall LMA Rating | Total LMA Miles | | | | | | | |

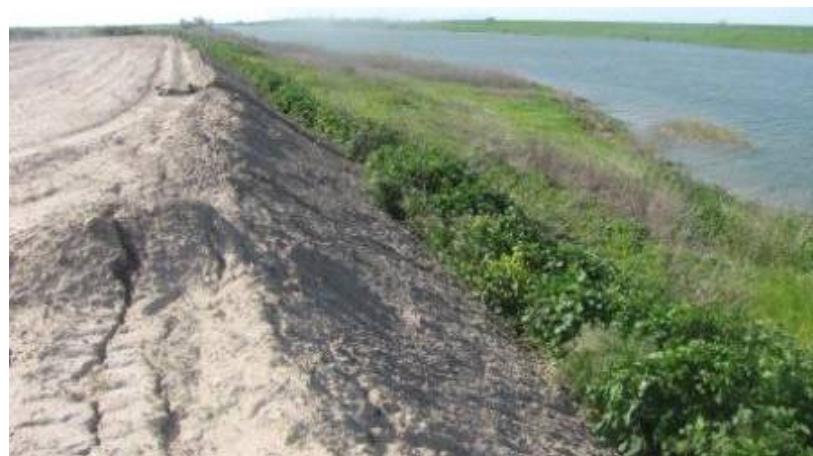
| richard_f_20130918_213.jpg | |

| Looking southwest at fill on waterside berm. | |

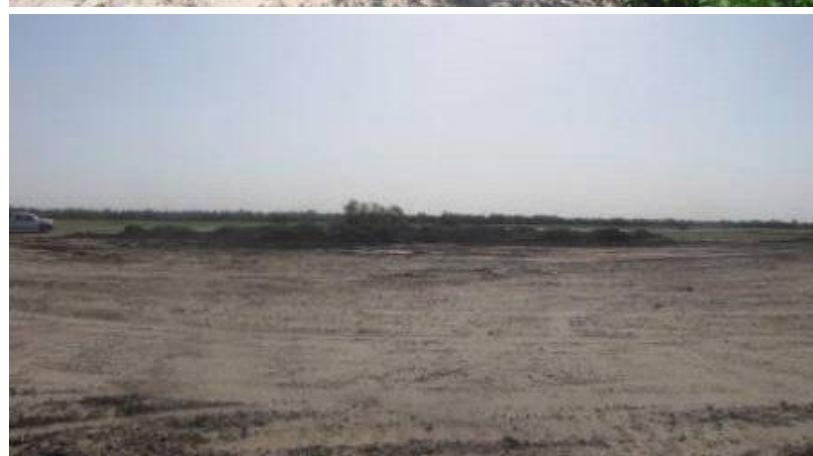
| richard_f_20130918_214.jpg | |

| Looking east at fill on waterside. | |

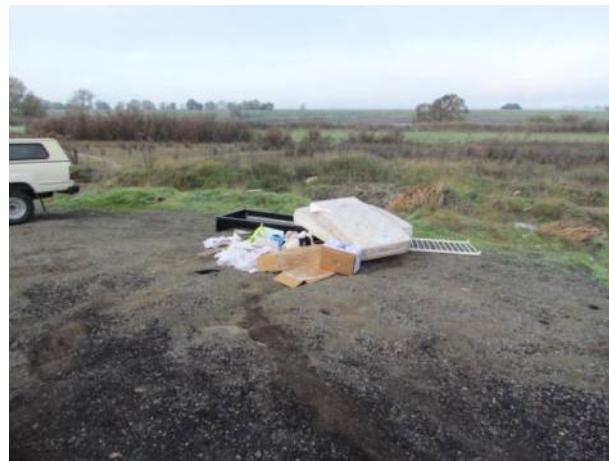
| richard_f_20130918_228.JPG | |

| Looking west at garbage on waterside shoulder and slope. | |

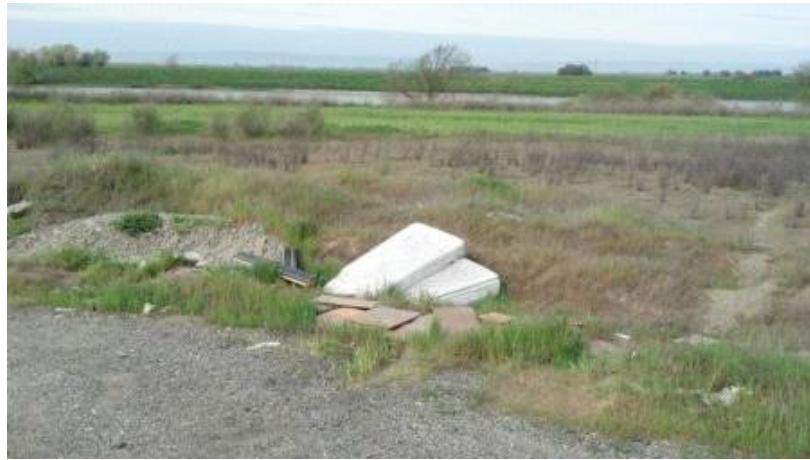
| richard_f_20130918_229.jpg | |

| Looking west at garbage on waterside berm. | |

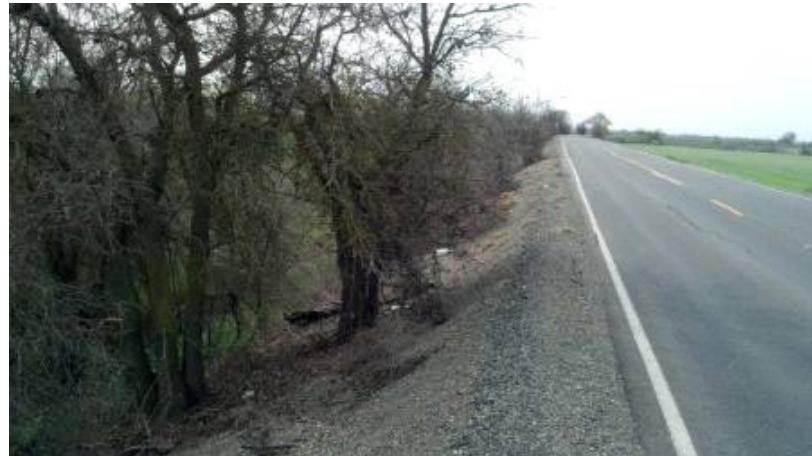
| richard_f_20130918_244.jpg | |

| Looking southeast at dense trees on landside slope and toe. (2013) | |

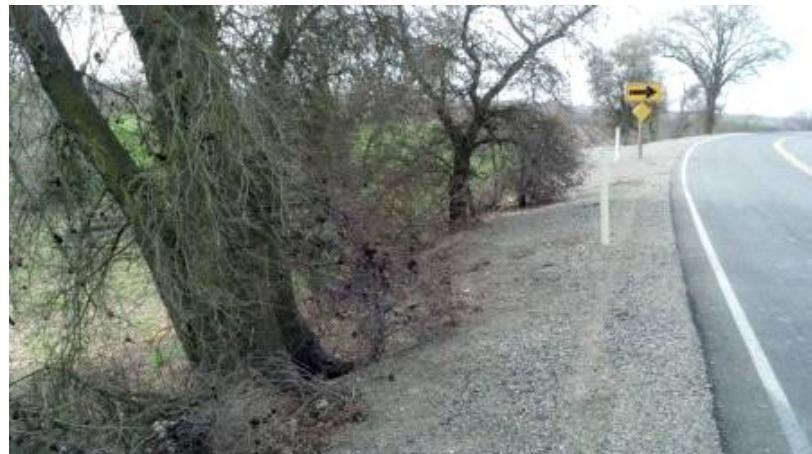
| richard_f_20130918_245.jpg | |

| Looking southeast at untrimmed trees on landside slope. | |

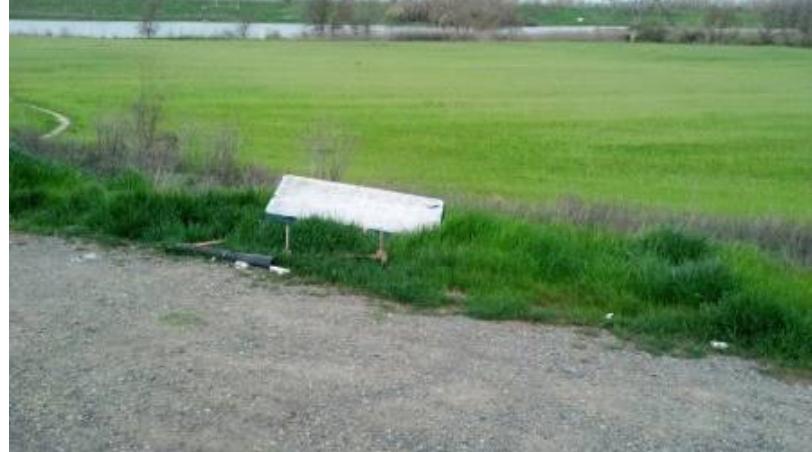
| richard_f_20130918_255.jpg | |

| Looking west at garbage on waterside shoulder. | |

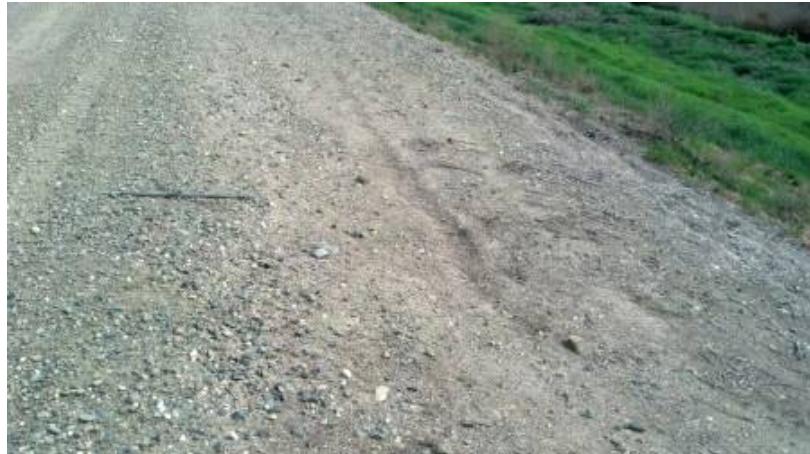
| richard_f_20130918_260.jpg | |

| Waterway | | | | | | | Bank | Unit Miles | Inspection Start/End | Inspector | |
|---|---|---|---|---|---|---|---|---|---|---|---|
| 20 | 3.24 | 3.26 | Earthen Levee | Slope Stability | LS Ma | M S1 : Repair slope instability. Inspector Comments: Depression on waterside shoulder and slope 60' x 20'. Earthen material appears to be sliding toward levee toe. | ° ° | ° ° | 51 Y | DWR ID: DWR_RD0999_01_s_2013_51 | |

| Looking northeast at depression on landside shoulder. | |

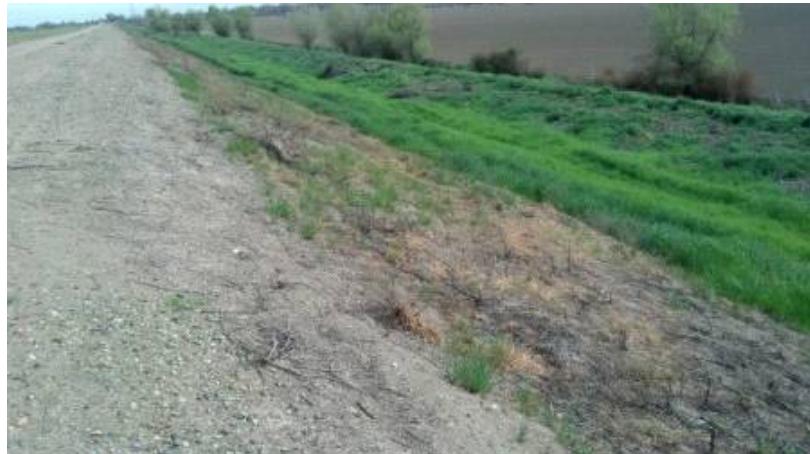
| richard_f_20130918_261.jpg | |

| Looking north at depression on landside shoulder and slope. | |

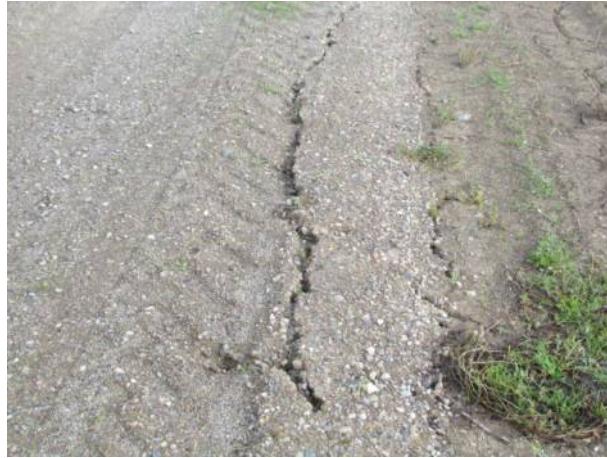
| richard_f_20130918_222.JPG | |

| Waterway | | | | | | | Bank | Unit Miles | Inspection Start/End | Inspector | |
|---|---|---|---|---|---|---|---|---|---|---|---|
| 22 | 3.63 | 3.66 | Earthen Levee | Slope Stability | LS Ob | M S1 : Repair slope instability. Inspector Comments: District Manager (Bob Webber) indicated that the area has a history of cracking and sloughing. District plans to repair site this summer. District repaired site without notifying the Dept. No compaction results provided. Unclear how site was repaired. Need more information about repair from district. During the fall inspection small cracks and sloughing were seen reappearing on landside shoulder and slope. | 38.454032 ° -121.590025 ° | 38.453680 ° -121.590173 ° | 6 Y | DWR ID: DWR_RD0999_01_s_2012_6 | |

| Looking north at cracking and sloughing on landside shoulder and slope. | |

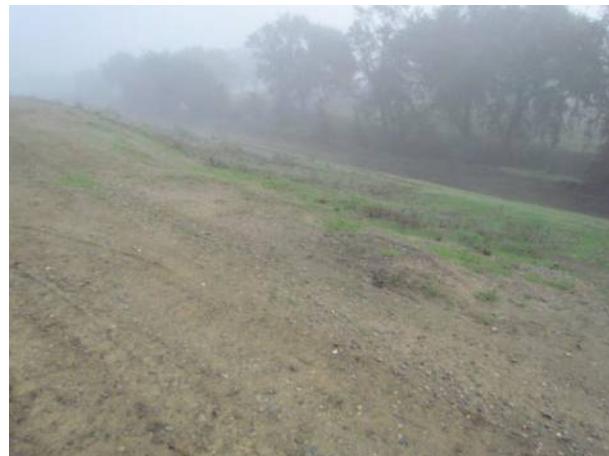
| richard_f_20130918_246.JPG | |

| Looking east at slope damage on landside slope. | |

| Waterway | | | | | | | | Bank | Unit Miles | Inspection Start/End | Inspector |
|---|---|---|---|---|---|---|---|---|---|---|---|
| 28 | 4.33 | 4.33 | Earthen Levee | Slope Stability | LS Ma | M | S3 : Repair the levee slope damaged by vehicle traffic and prevent access where possible. | 38.444561 ° | 38.444561 ° | 35 | |

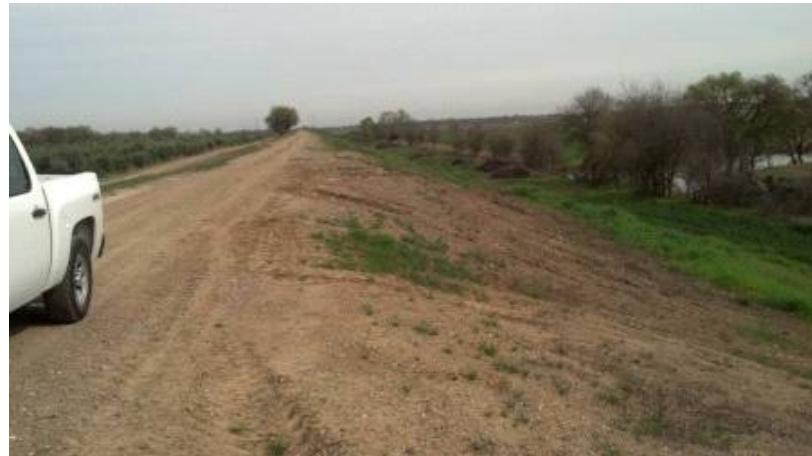
| richard_f_20130918_247.jpg | |

| Looking north at slope damage caused by vehicle traffic. | |

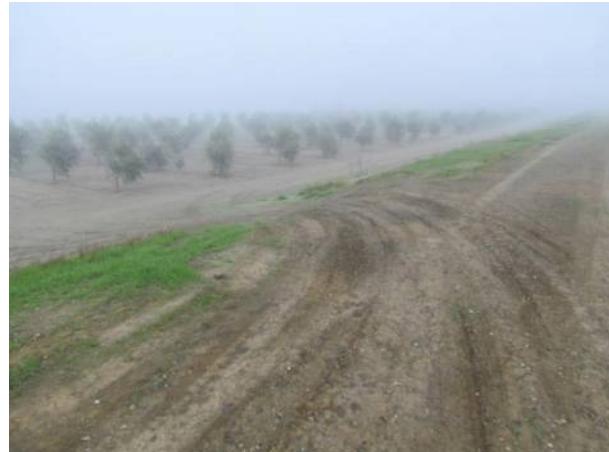
| richard_f_20130918_239.JPG | |

| Waterway | | | | | | | | Bank | Unit Miles | Inspection Start/End | Inspector |
|---|---|---|---|---|---|---|---|---|---|---|---|
| 29 | 4.33 | 4.33 | Earthen Levee | Slope Stability | WS Ma | M | S3 : Repair the levee slope damaged by vehicle traffic and prevent access where possible. Inspector Comments: Local farmer causing slope damage by driving equipment and trucks on slope. | 38.444560 ° | 38.444560 ° | 27 | |

| Looking northwest at slope damage caused by vehicle traffic. | |

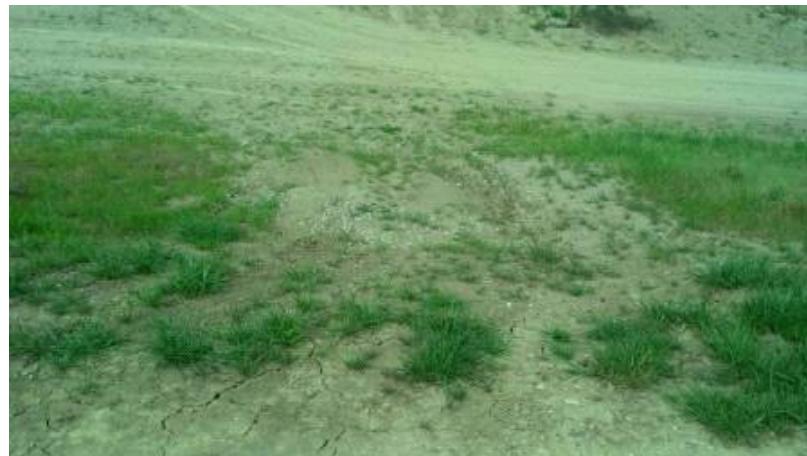
| richard_f_20130918_240.jpg | |

| Looking west at slope damage on waterside slope. | |

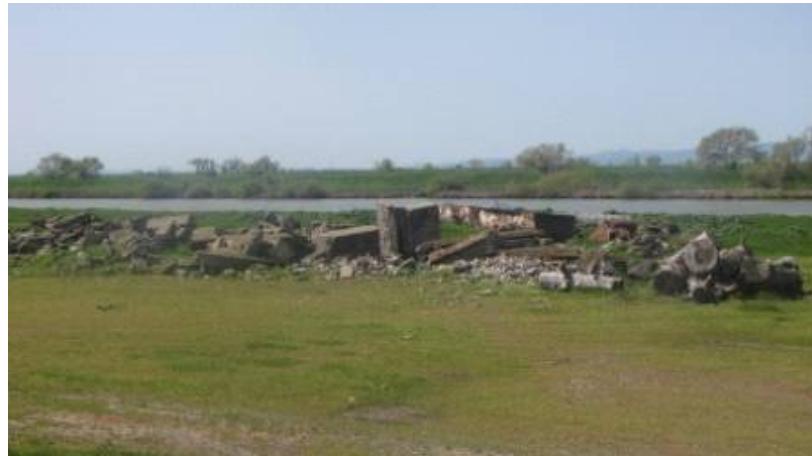
| richard_f_20130918_237.jpg | |

| Looking west at concrete rubble on waterside berm. | |

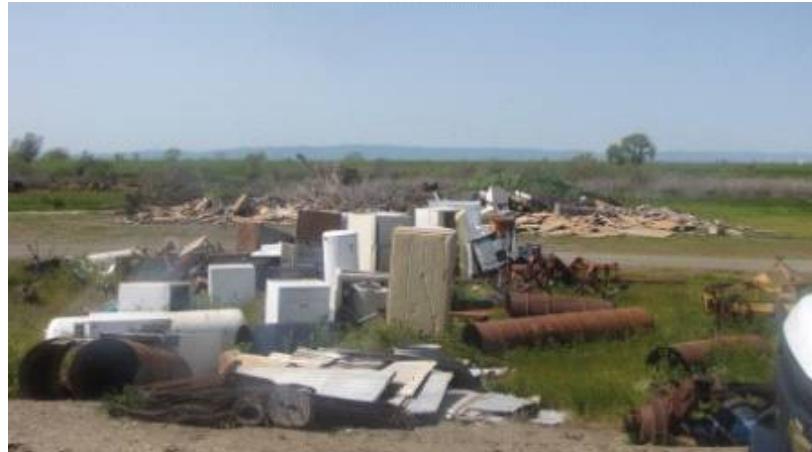
| richard_f_20130918_241.jpg | |

| Looking southwest at garbage on waterside toe and berm. | |

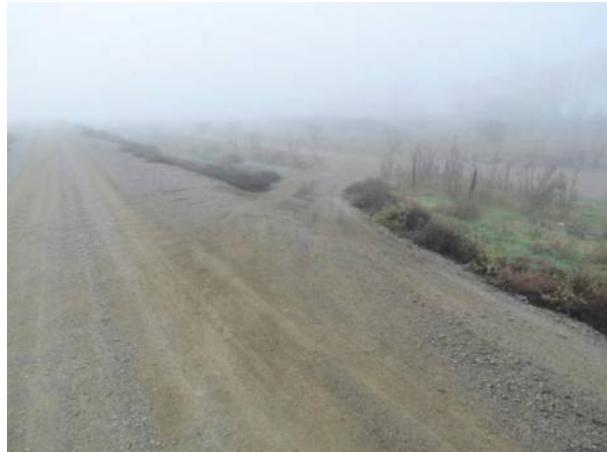
| richard_f_20130918_256.JPG | |

| Waterway | | | | | | | | Bank | Unit Miles | Inspection Start/End | Inspector |
|---|---|---|---|---|---|---|---|---|---|---|---|
| 53 | 11.85 | 11.85 | Earthen Levee | Slope Stability | WS Ma | M S3 : Repair the levee slope damaged by vehicle traffic and prevent access where possible. Inspector Comments: Slope damage caused by vehicle traffic | | 38.342068 ° -121.641944 ° | 38.342068 ° -121.641944 ° | 48 Y | DWR ID: DWR_RD0999_01_f_2012_48 |

| Looking southwest at slope damage caused by vehicle traffic on waterside slope. | |

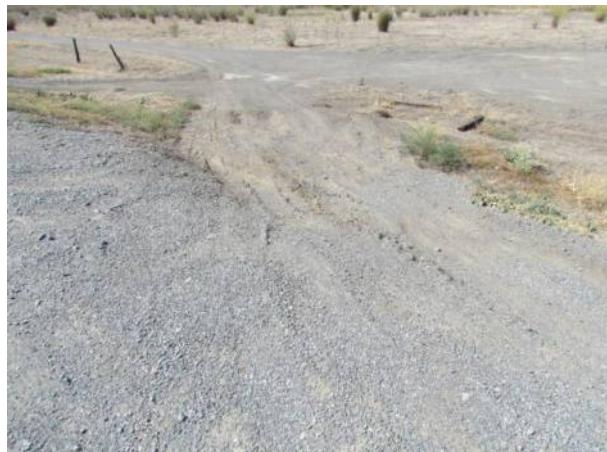
| richard_f_20130927_466.JPG | |

| Looking southwest at slope damage caused by vehicle traffic. 2013 | |

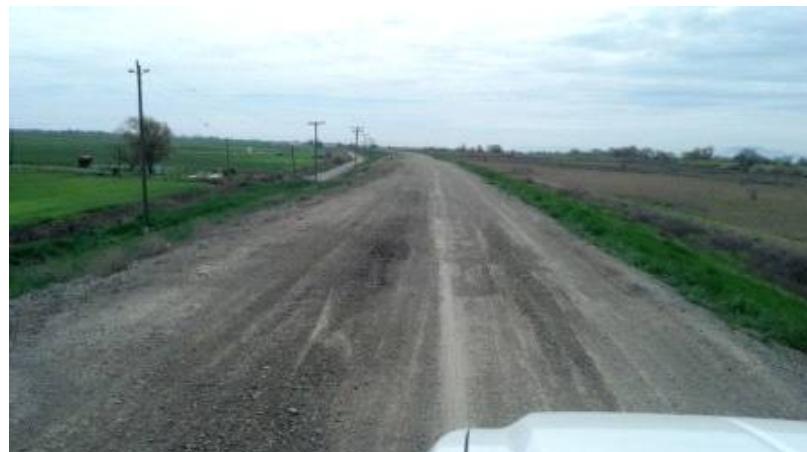
| richard_f_20130918_234.jpg | |

Looking south at rutting on levee crown. Spring 2013

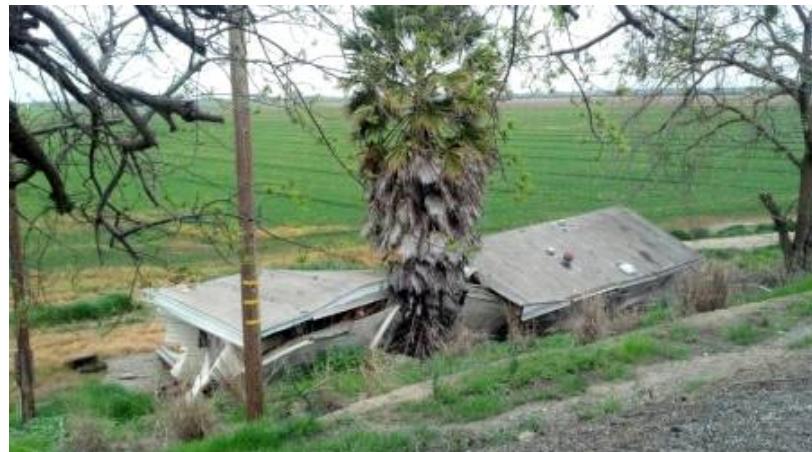
| richard_f_20130918_267.jpg | |

| Looking northwest at dilapidated building on landside toe. Spring 2013 | |

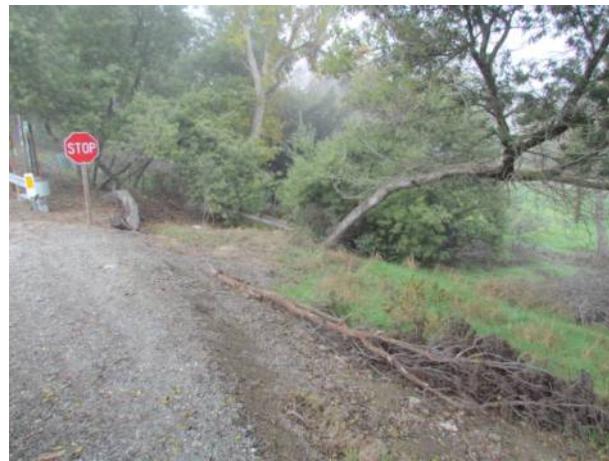
| richard_f_20130918_285.JPG | |

| Looking southeast at dense trees on landside slope and toe. | |

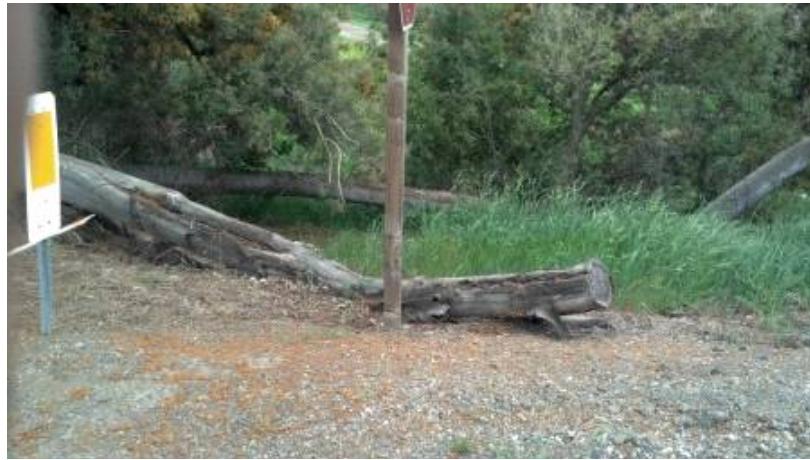
| richard_f_20130918_278.jpg | |

| Looking northwest at tree limb on landside slope. | |

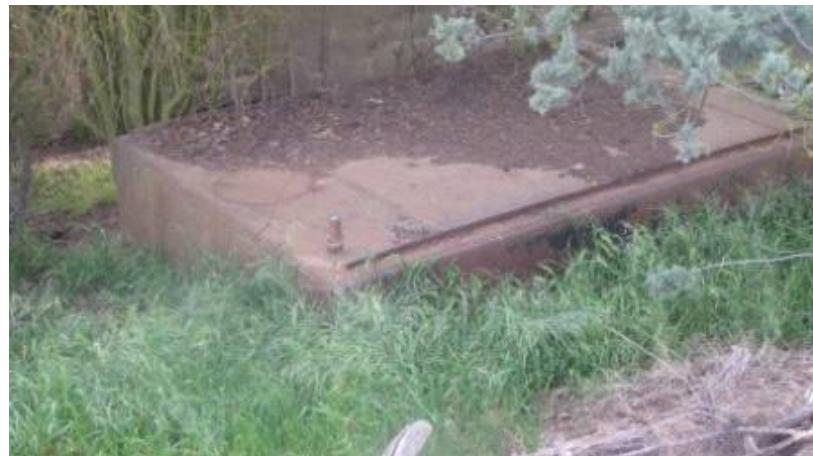
| richard_f_20130918_277.jpg | |

| Looking north at a tank on the landside slope and toe. | |

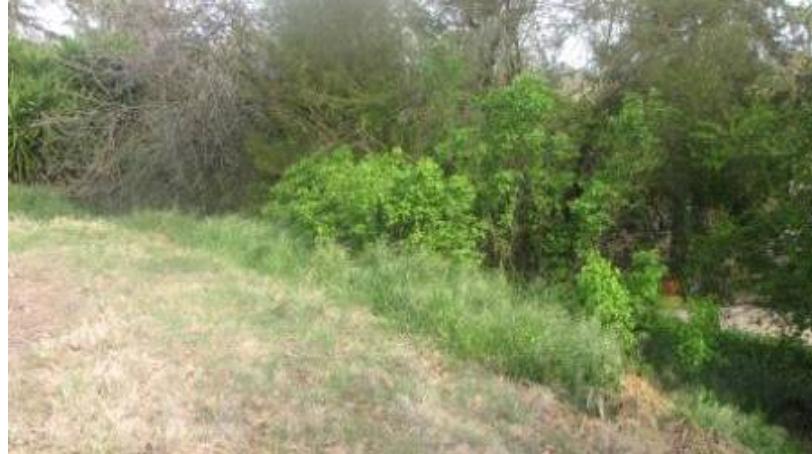
| richard_f_20130918_280.jpg | |

| Looking southwest at dense veg. on landside toe. | |

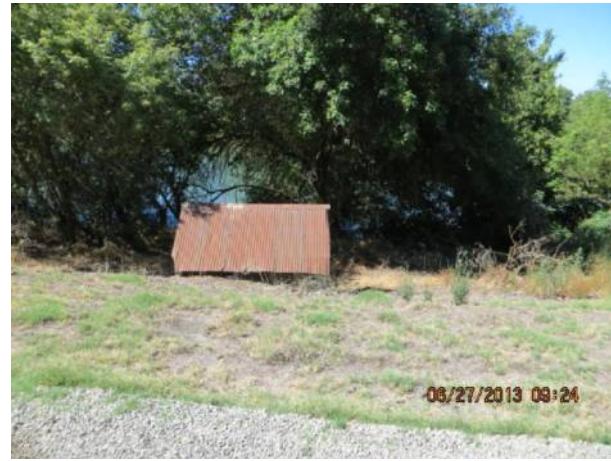
| UCIP_8138.jpg | |

| Pumphouse on WS slope. | |

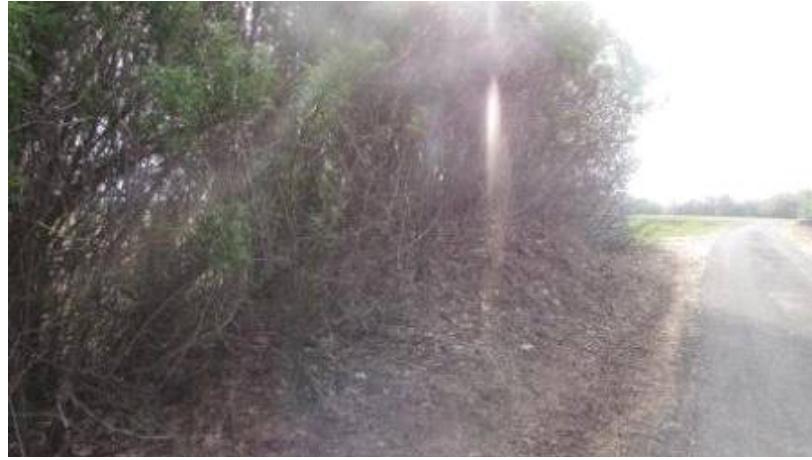
| richard_f_20130918_275.jpg | |

| Looking southwest at elderberry bush on landside shoulder and slope. | |

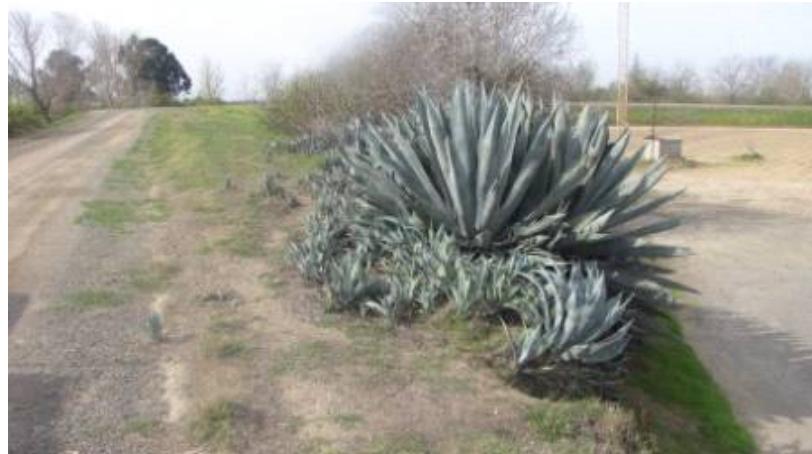
| richard_f_20130918_303.jpg | |

| Looking east at cactus on landside slope during 2011 spring inspection. | |

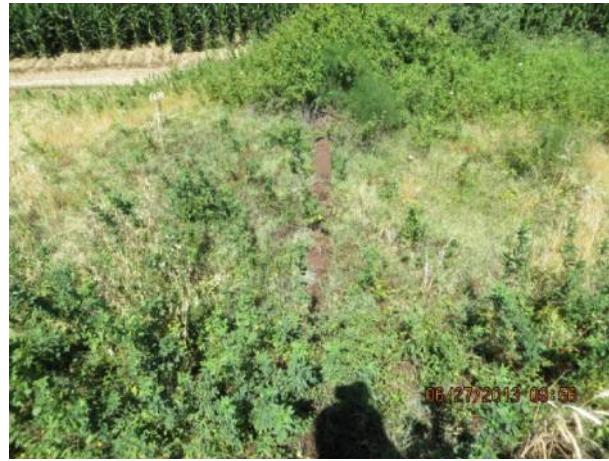
| UCIP_8140.jpg | |

| Pipe visible on LS slope. | |

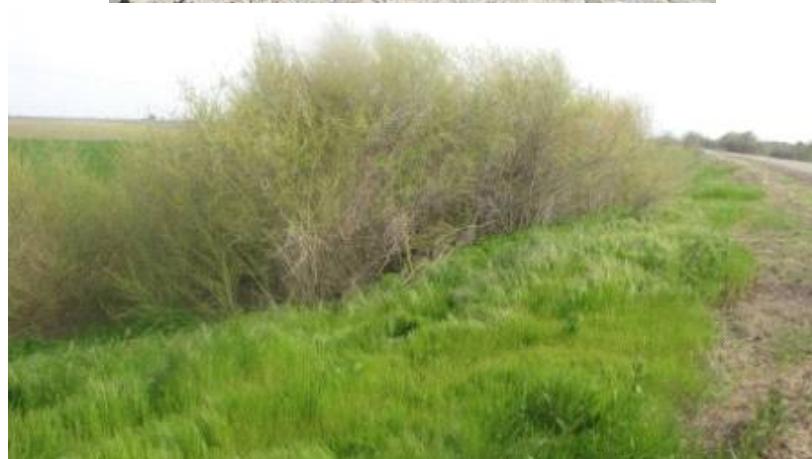
| richard_f_20130918_313.jpg | |

| Looking north at willow on landside slope and toe. | |

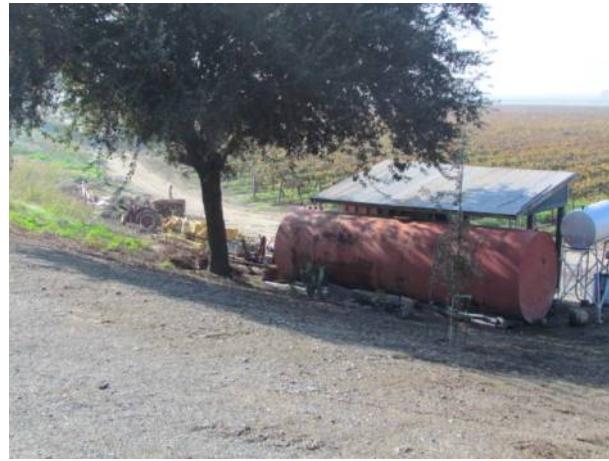
| richard_f_20130918_317.JPG | |

| Looking southwest at farm equipment stored at landside toe. (Fall Inspection 2012) | |

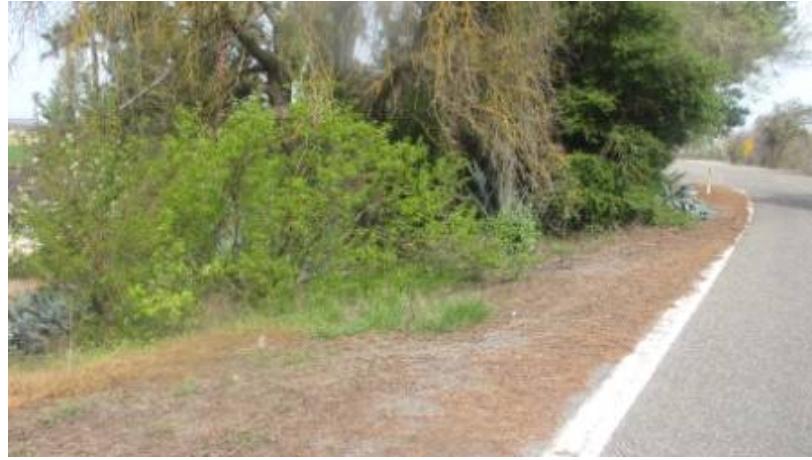
| richard_f_20130918_311.jpg | |

| Looking northwest at landscaping and dense veg. on landside slope and toe. | |

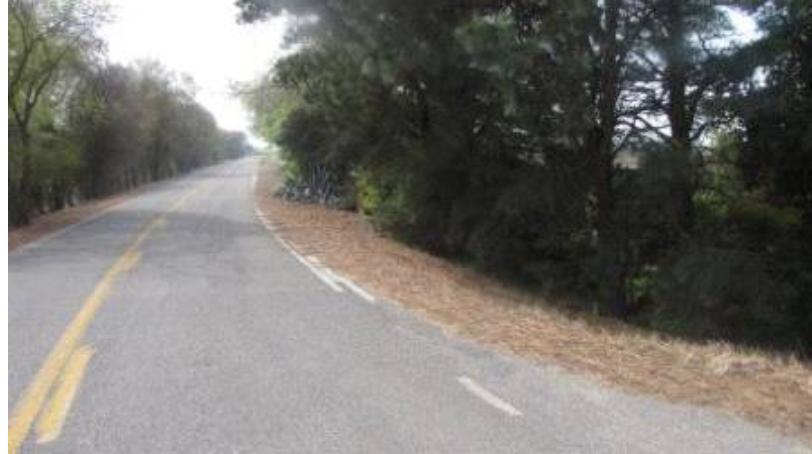
| richard_f_20130918_312.jpg | |

| Looking south at landscaping and dense veg. on landside slope and toe. | |

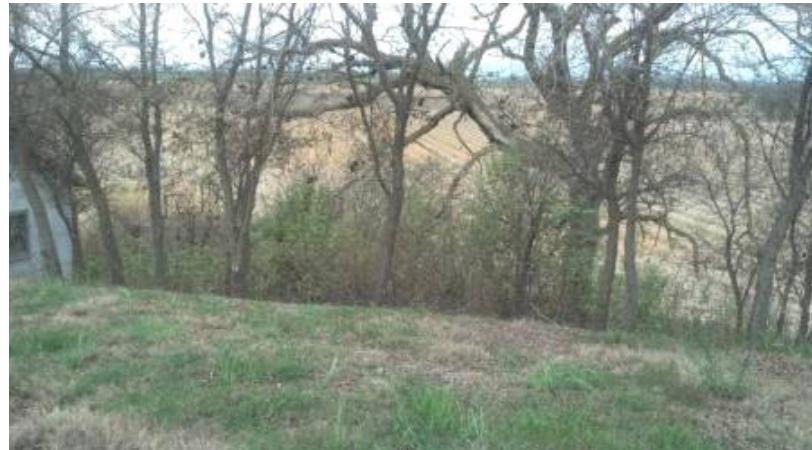
| richard_f_20130918_310.jpg | |

| Looking west at dense trees on landside toe. | |

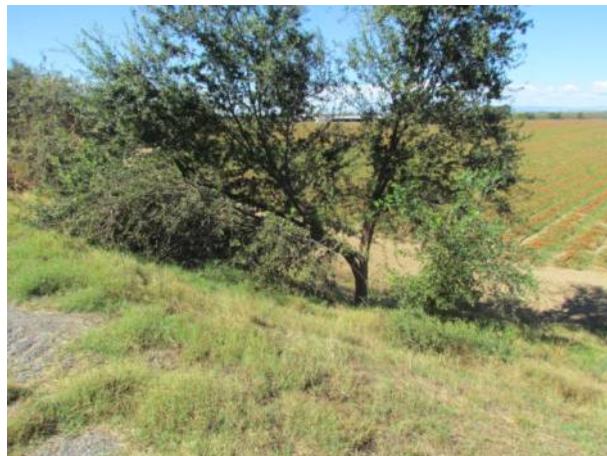
richard_f_20130927_480.JPG

Looking southwest at broken tree limb on landward slope.

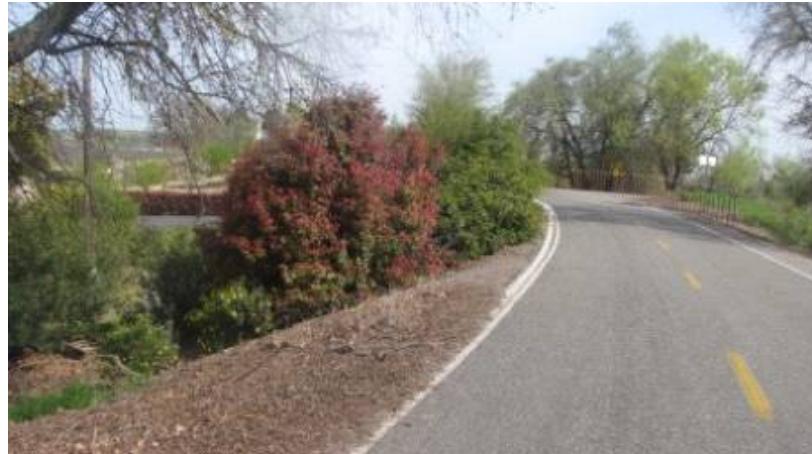
| richard_f_20130918_314.jpg | |

| Looking northwest at landscaping on landside slope and toe. (Spring 2011) | |

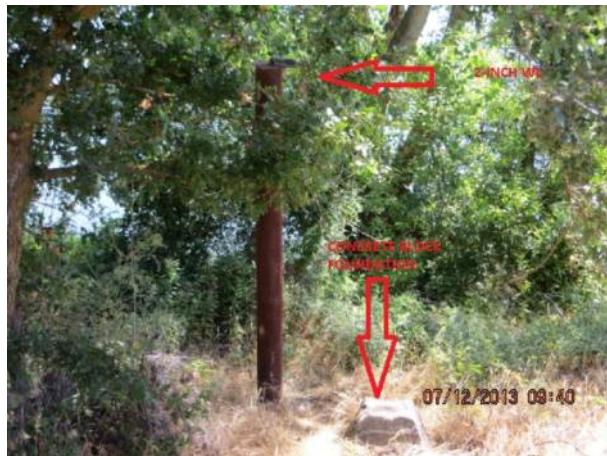
| Pipe visible at top of steel standpipe. Foundation for pump station visible on WS slope. | UCIP_8610.jpg |

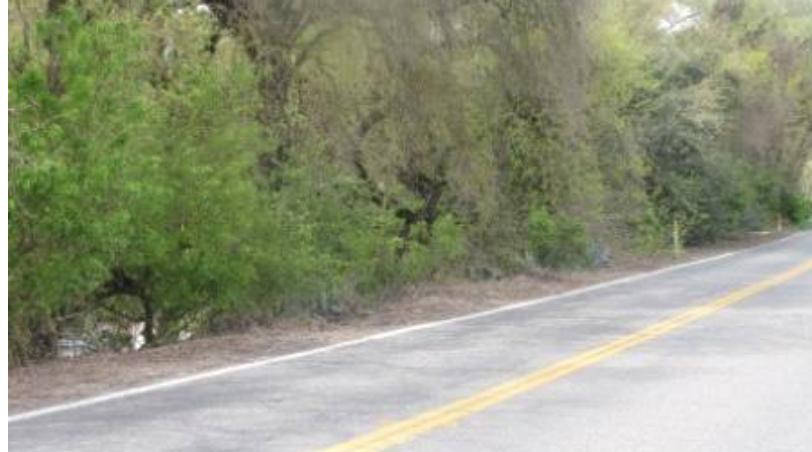
| richard_f_20130918_339.jpg | |

| Looking west at dense trees on waterside slope. | |

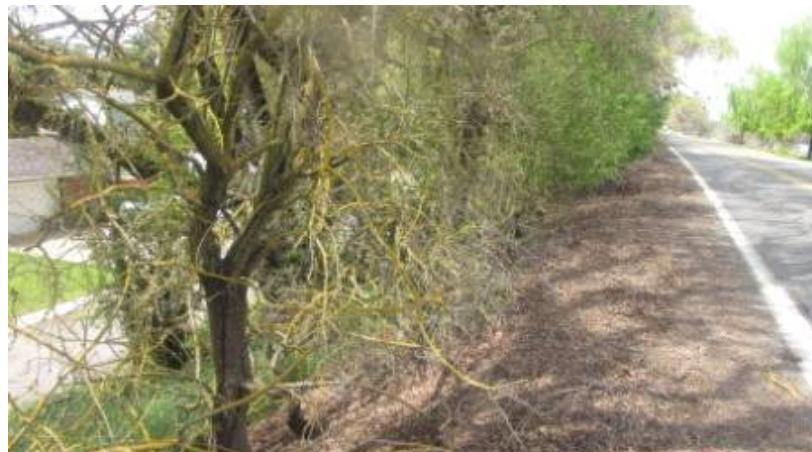
| richard_f_20130918_340.jpg | |

| Looking northwest at dense trees on landside slope and toe. | |

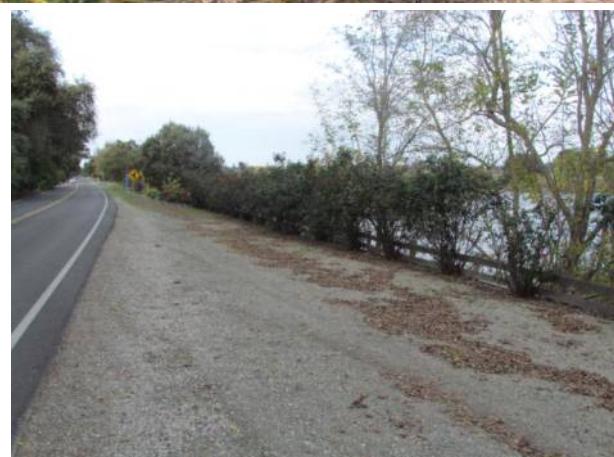
| richard_f_20130918_331.JPG | |

| Looking north at rose bushes on waterside slope. | |

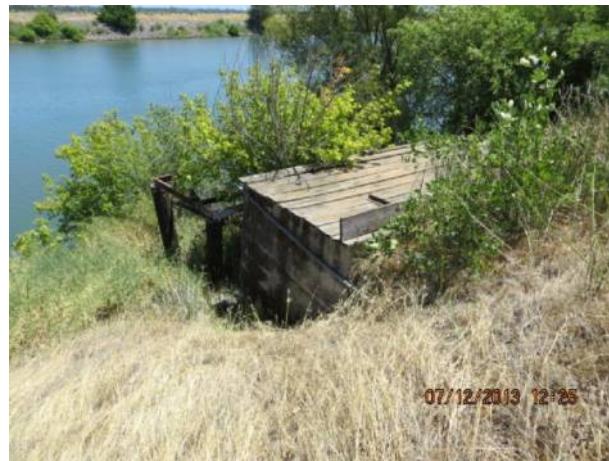
| UCIP_8637.jpg | |

| Slide gate in 9'X18' concrete box on WS slope. | |

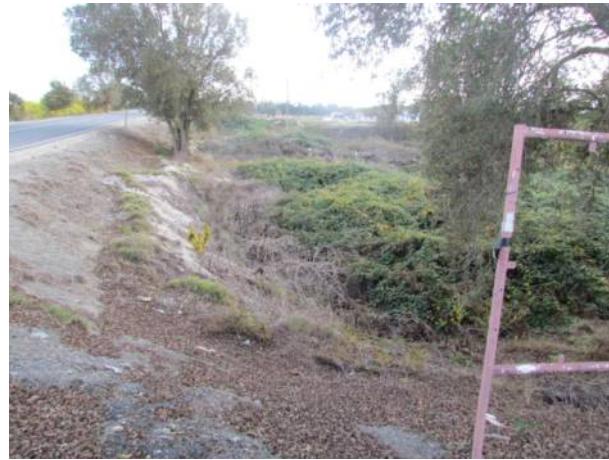
| richard_f_20130918_345.JPG | |

| Looking south at dense berryvines on landside toe. 2012 | |

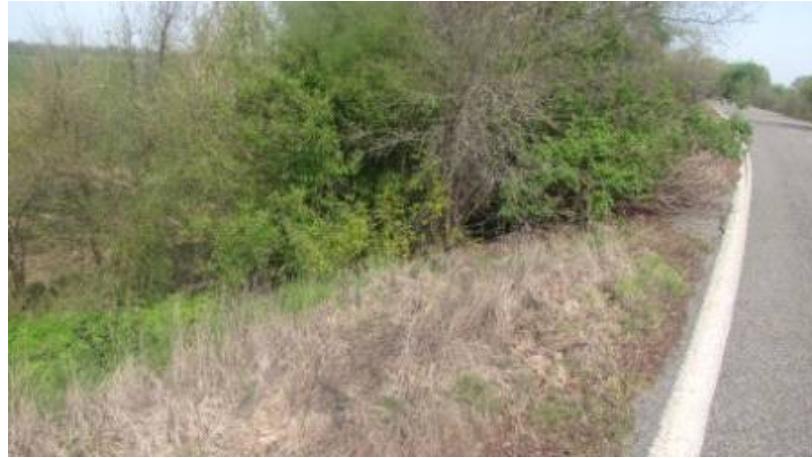
| richard_f_20130918_351.JPG | |

| Looking north at dense vegetation on landside slope and toe. | |

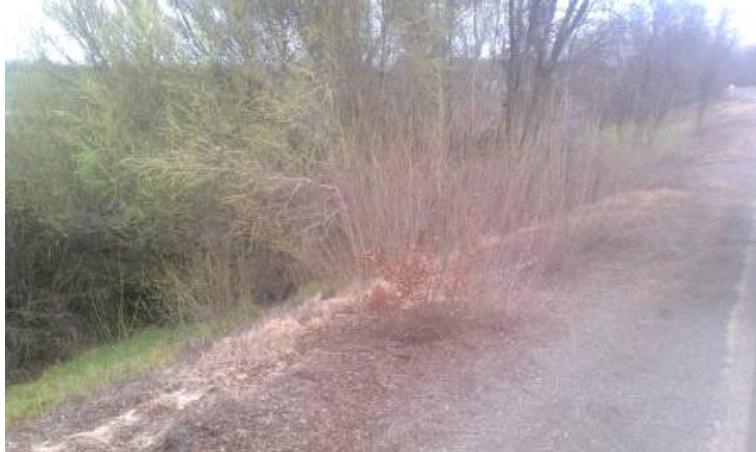
| richard_f_20130918_367.jpg | |

| Looking northwest at dense vegetation on landside slope and toe. | |

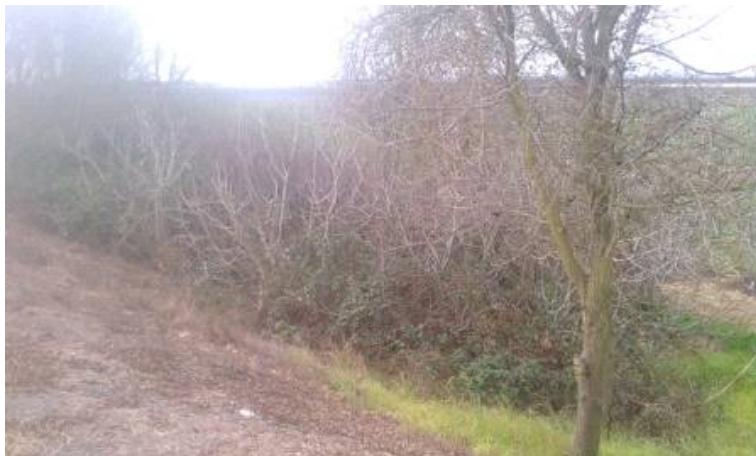
| richard_f_20130918_368.jpg | |

| Looking southwest at dense berry vines on landside toe. | |

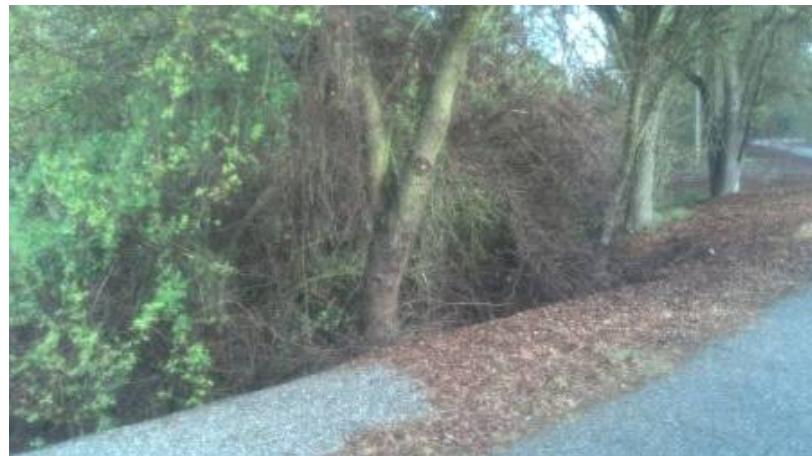
| richard_f_20130918_355.jpg | |

| Looking northwest at dense trees at landside slope and toe. Spring 2013 | |

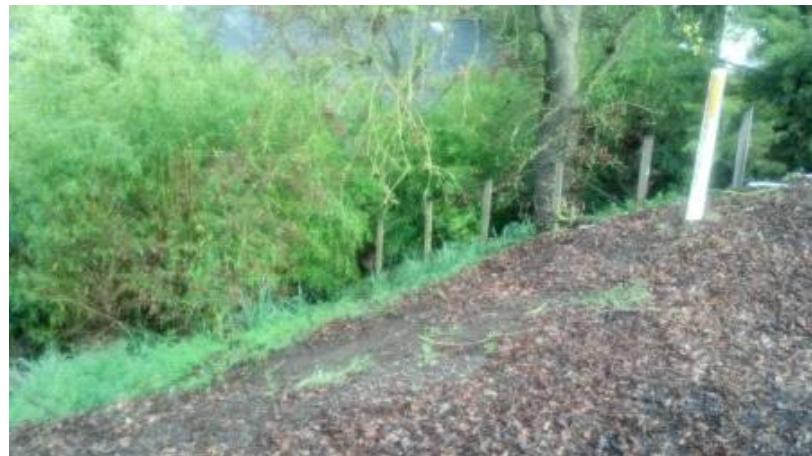
| richard_f_20130918_424.jpg | |

| Looking at dense trees on landside slope and toe. | |

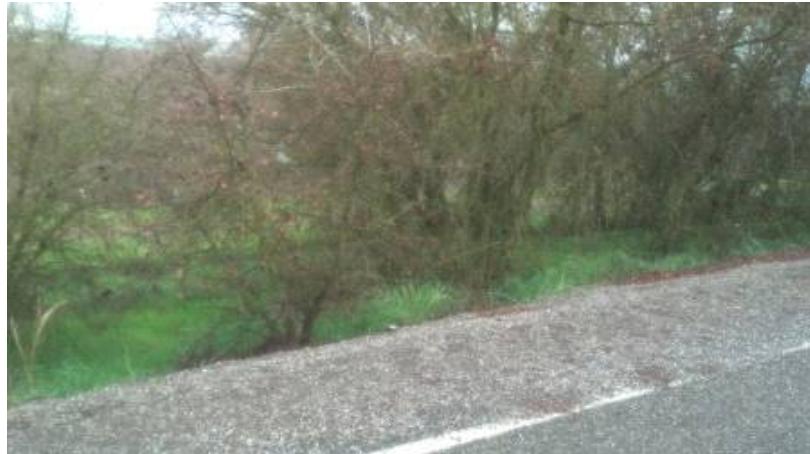
| richard_f_20130918_358.jpg | |

| Looking west at dense trees on landside slope and toe. | |

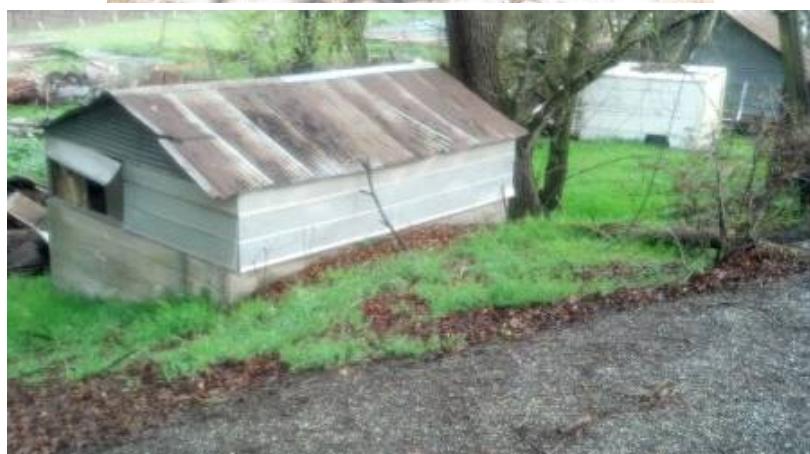
| richard_f_20130918_428.jpg | |

| Looking northwest at pump building on landside slope and toe. | |

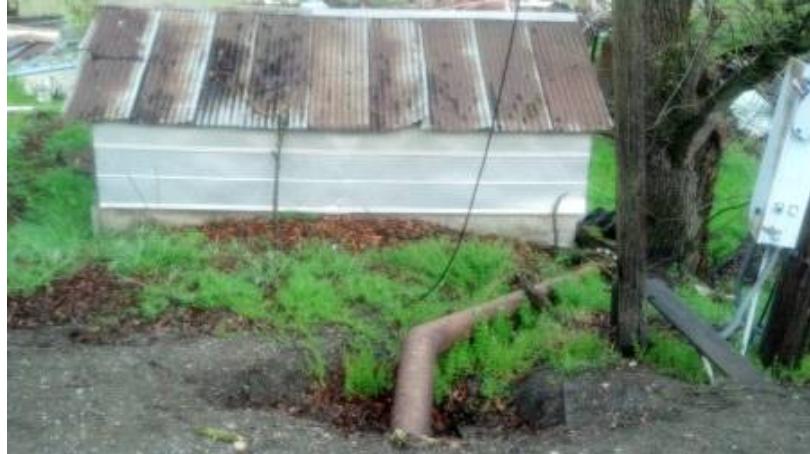
| richard_f_20130918_429.jpg | |

| Looking west at pump building on landside slope and toe. | |

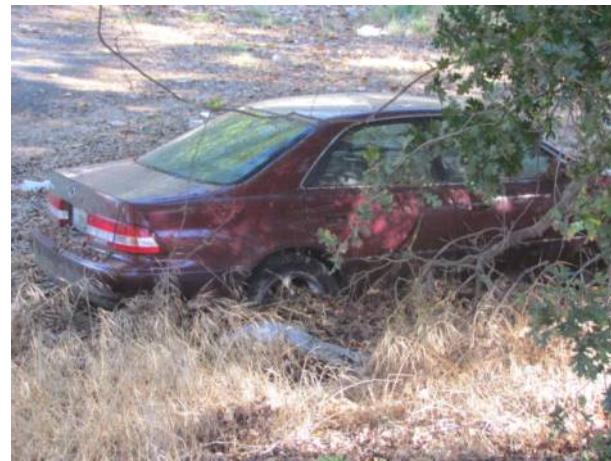
| richard_f_20130927_483.JPG | |

| Looking west at abandoned vehicle on landward toe. | |

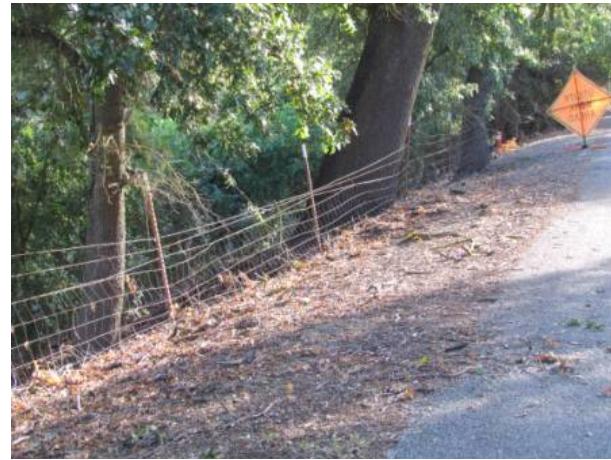
| richard_f_20130918_398.jpg | |

| Looking north at fence along landside slope. | |

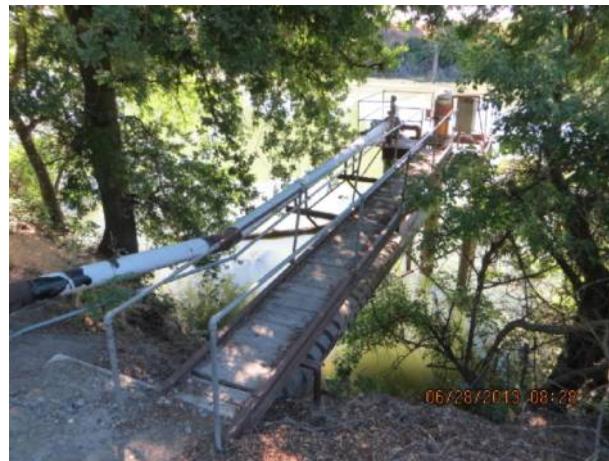
| UCIP_9078.jpg | |

| Pump on pier at WS. | |

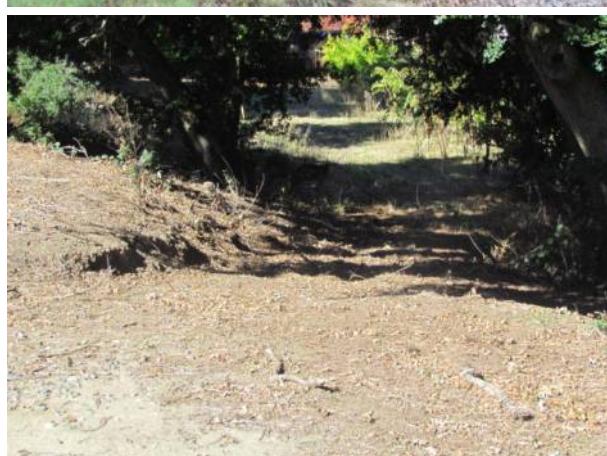
| richard_f_20130927_495.JPG | |

| Looking west at levee damage due to vehicle traffic. | |

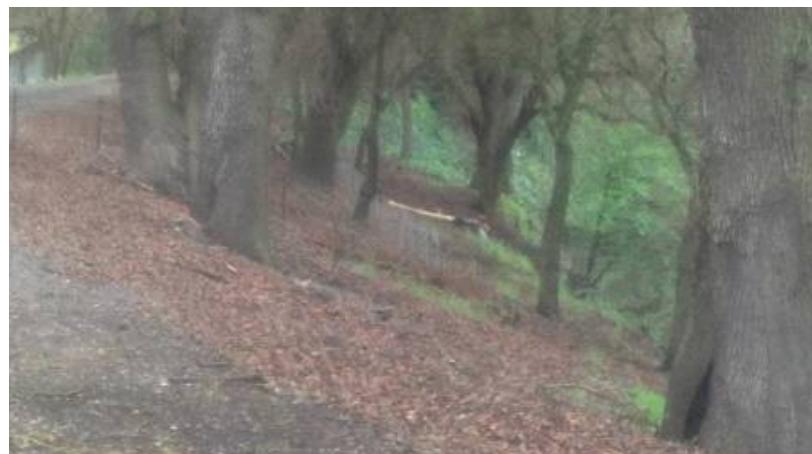
| richard_f_20130918_386.jpg | |

| Looking northeast at fence on waterside slope. | |

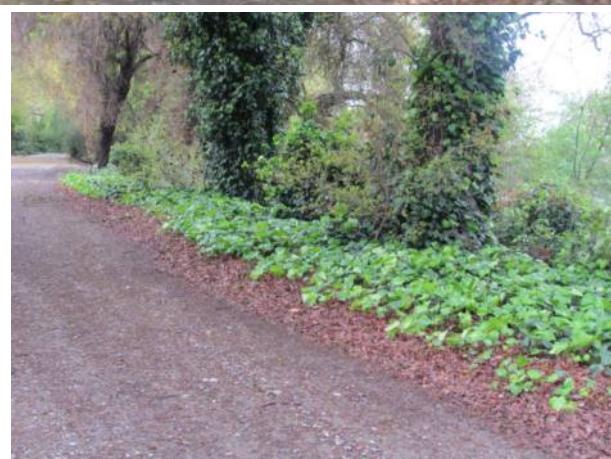
| richard_f_20130918_383.jpg | |

| Looking northeast at dense groundcover and vegetation on waterside slope. | |

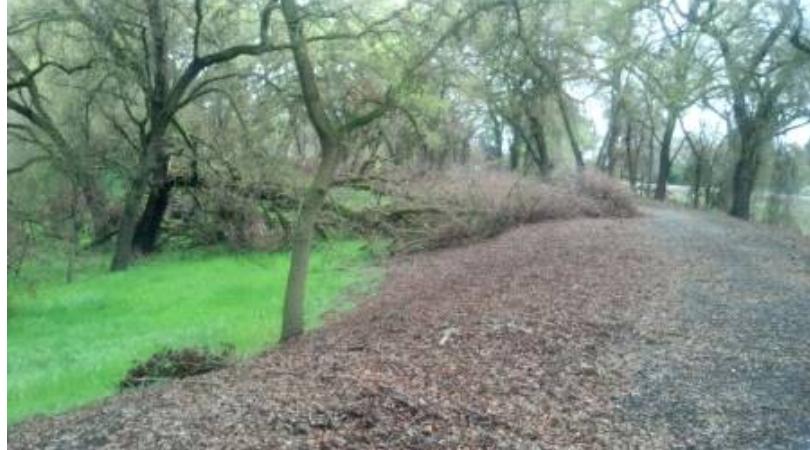
| richard_f_20130918_379.jpg | |

| Looking northwest at large tree limb on landside toe and slope. | |

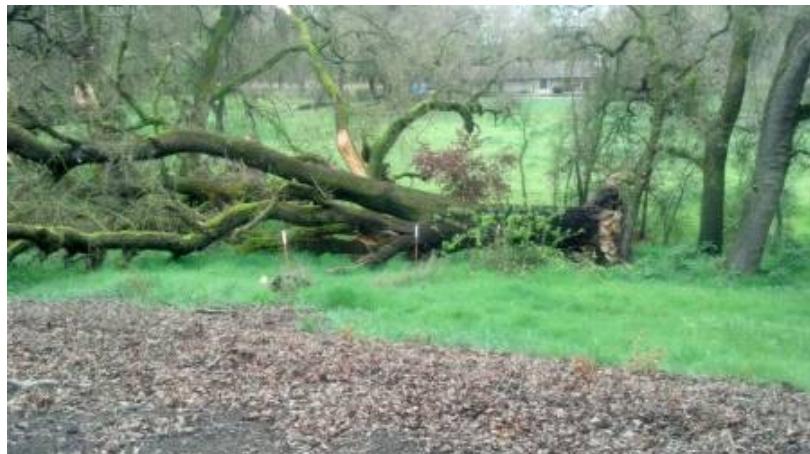
| richard_f_20130918_380.jpg | |

| Looking west at large tree on landside slope and toe. | |
